Lee Vining Hydroelectric Project

FERC No. 1388

Technical Report Review
Stakeholder Meeting

May 14, 2024

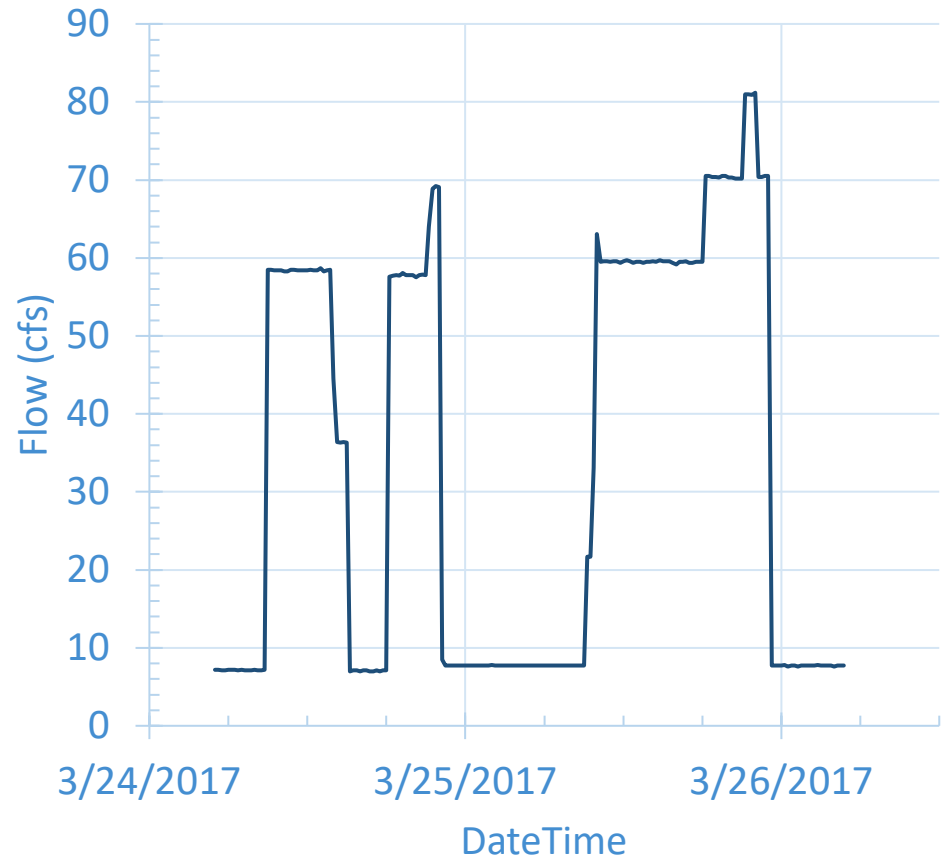
Hydraulic Model – March 2017 Event

- Modeled three optimization events over a 2-day span in March 2017
- Can compare velocities and depths during events
- Can calculate average event travel times downstream

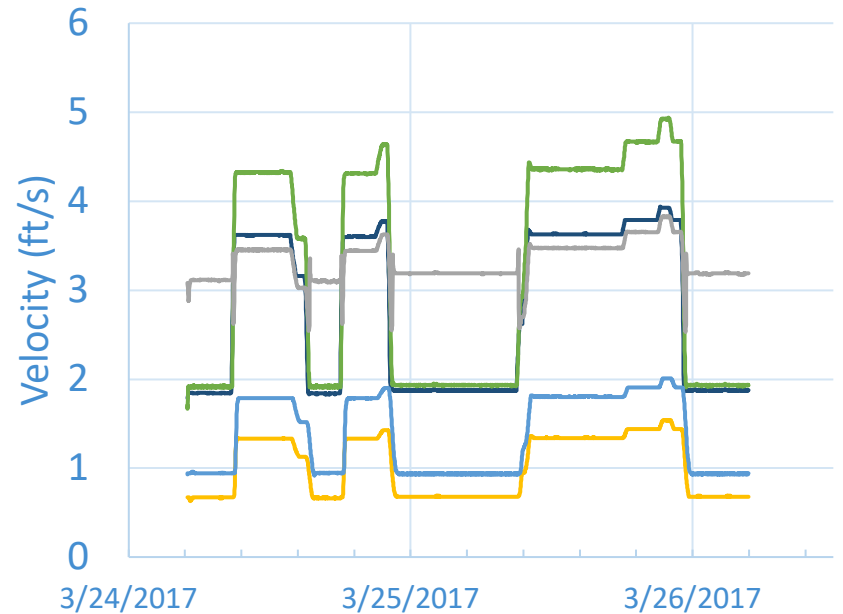
Depth and Velocity Results

Velocity

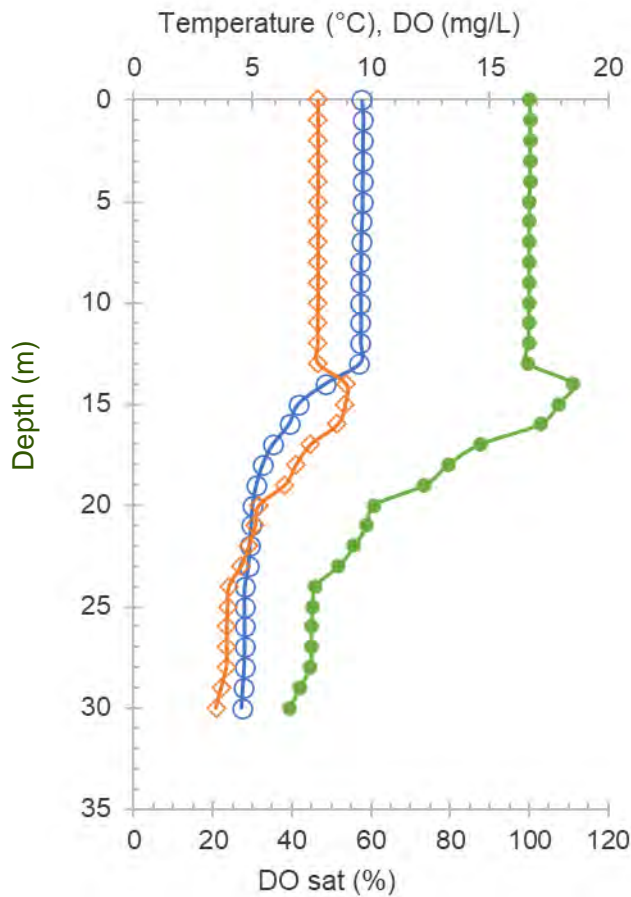
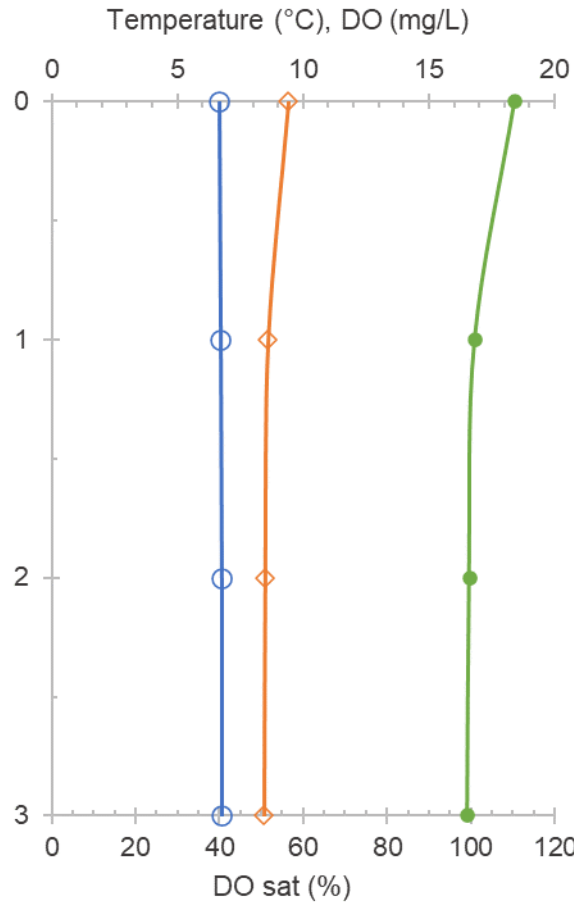
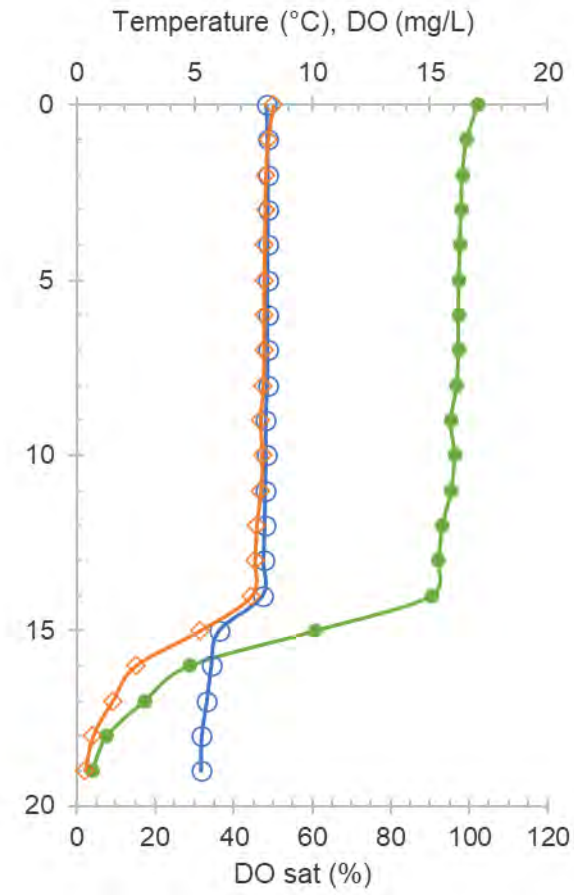
—●— DO saturation —○— Temperature —◇— DO

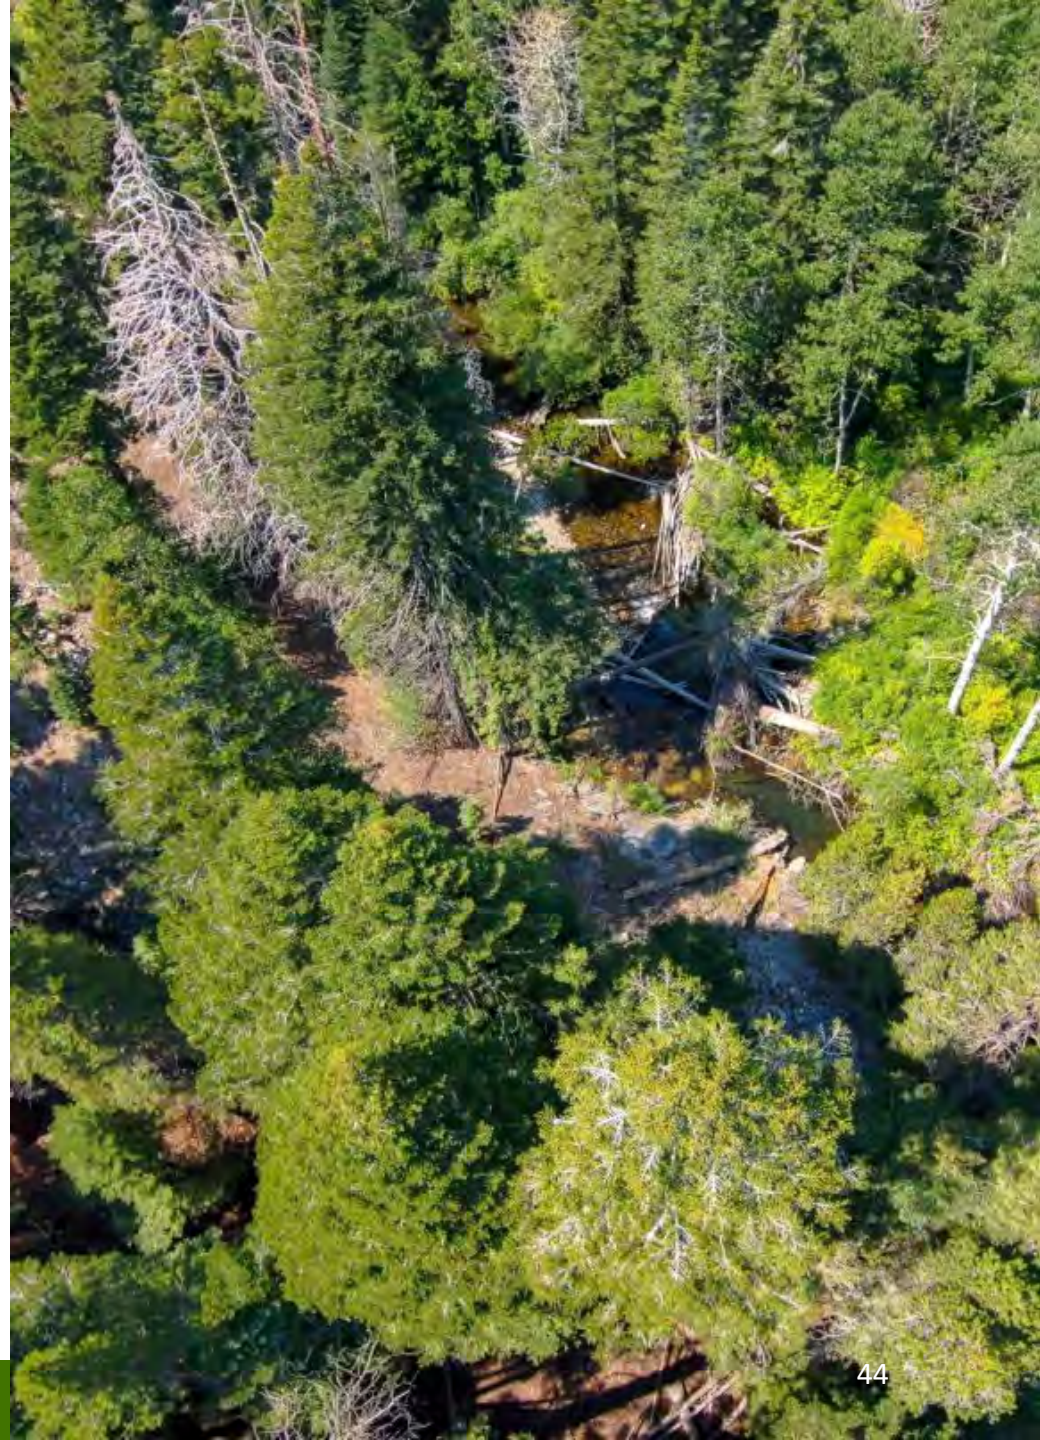
- 2022
 - Fecal coliform ≤ 2 – 20 cfu/100 mL except for one date*
 - High levels (49–350 MPN/100 mL) observed at all sites on Sept 15, 2022
- 2023
 - Fecal coliform were ≤ 2 cfu/100 mL
 - *E. coli* levels were < 1.8 MPN/100 mL

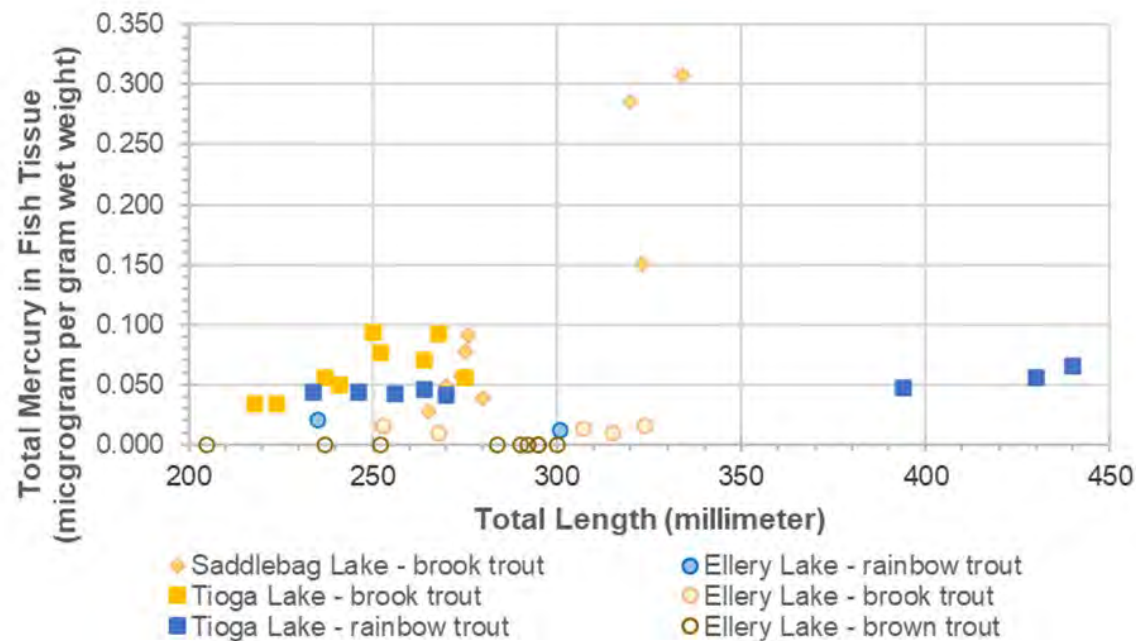
- Concentrations were lowest in fish from Ellery Lake and greatest in fish from Saddlebag Lake
- The highest concentrations were measured in large brook trout captured in Tioga and Saddlebag lakes

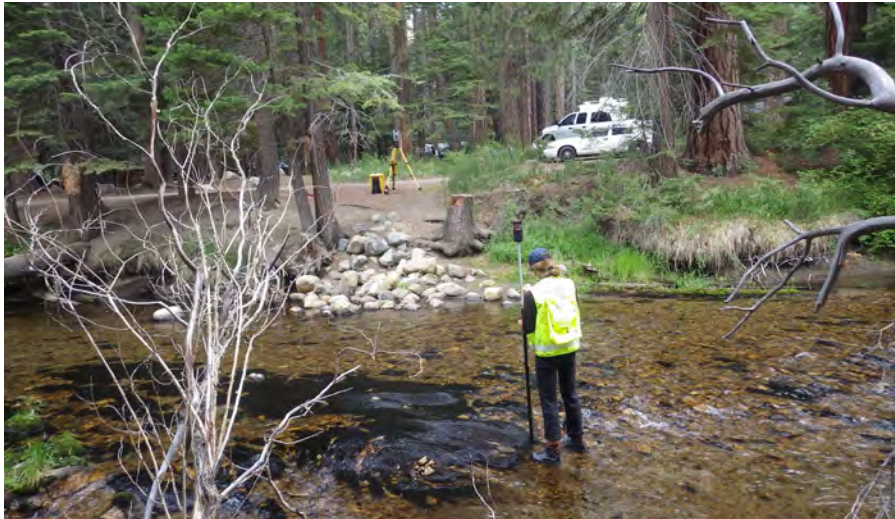
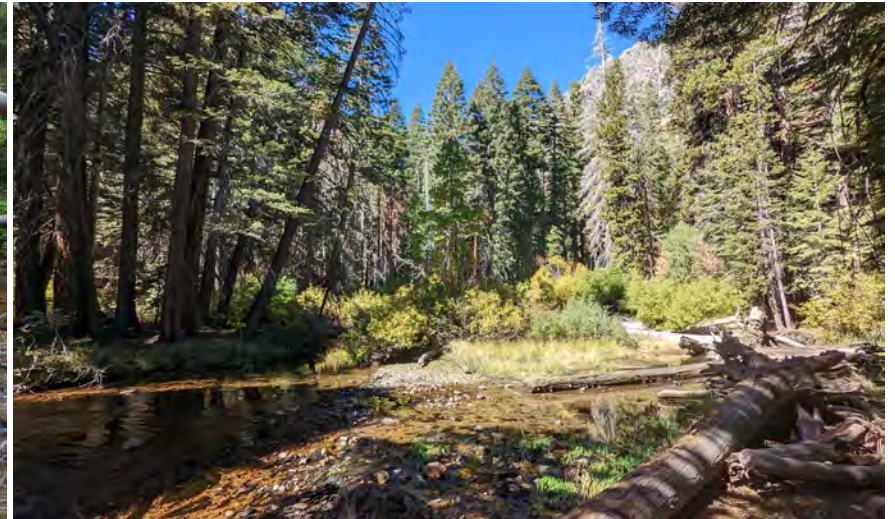
- Plane bed and pool-riffle morphology, highly confined, large woody debris (LWD) jams
- Average slope 0.07%, bankfull widths 25-30 feet
- Dominated by gravel (45%) and cobble (30%)
- 25 of 76 tracer rocks recovered (33% recovery rate)
- 24 tracer rocks traveled more than 1 foot, one did not move

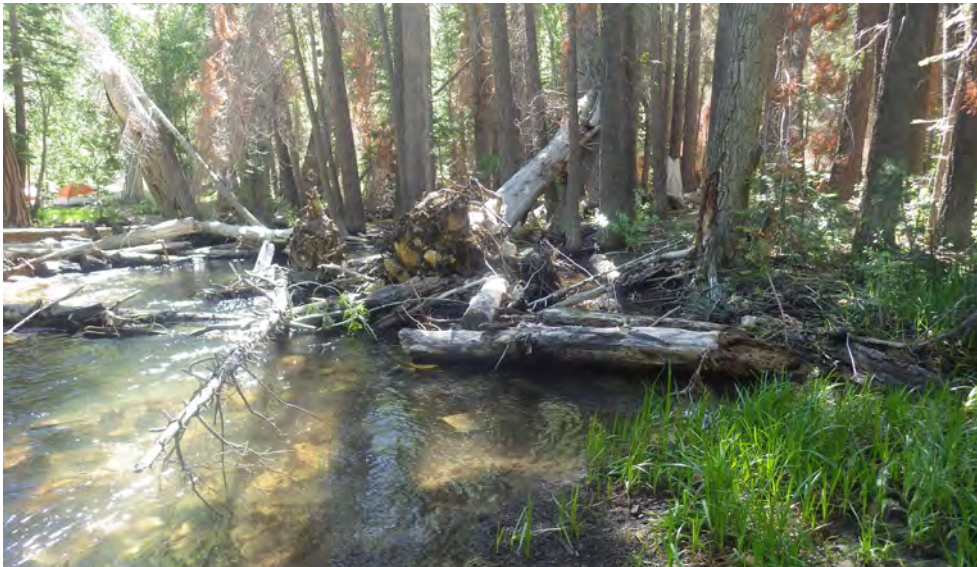
- Site LLV-G2
 - Morphology transitions from cascade to pool-riffle and plane-bed, LWD jams
 - Average slope 1.3%, bankfull widths 25-45 feet
 - Dominated by gravel (41%) and boulder (31%)
 - 21 of 68 tracer rocks recovered (31% recovery rate)
 - 10 tracer rocks traveled more than 1 foot, 11 did not move

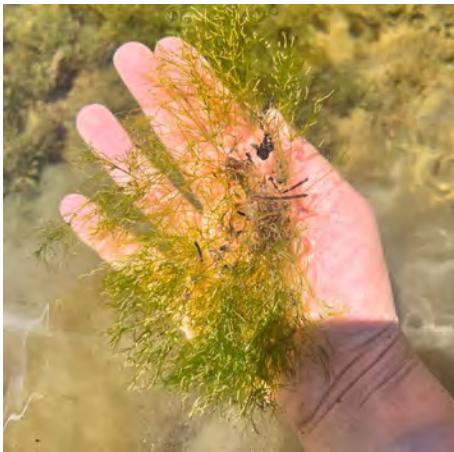
Brittlewort algae (*Nitella* sp.)

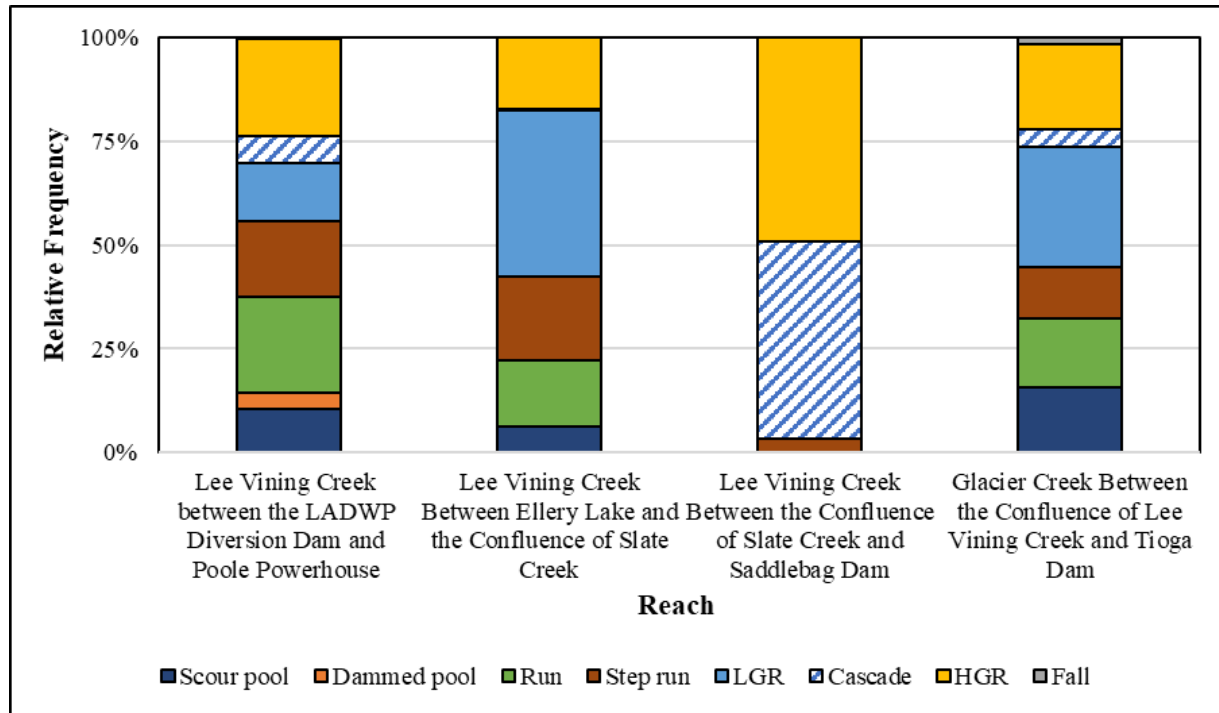
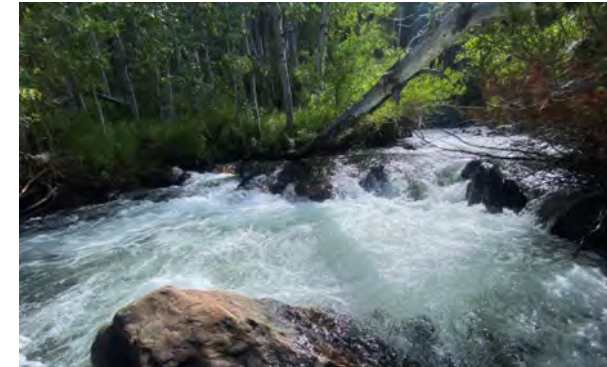
Lower Lee Vining Creek

- Reaches primarily cobble and boulder substrate

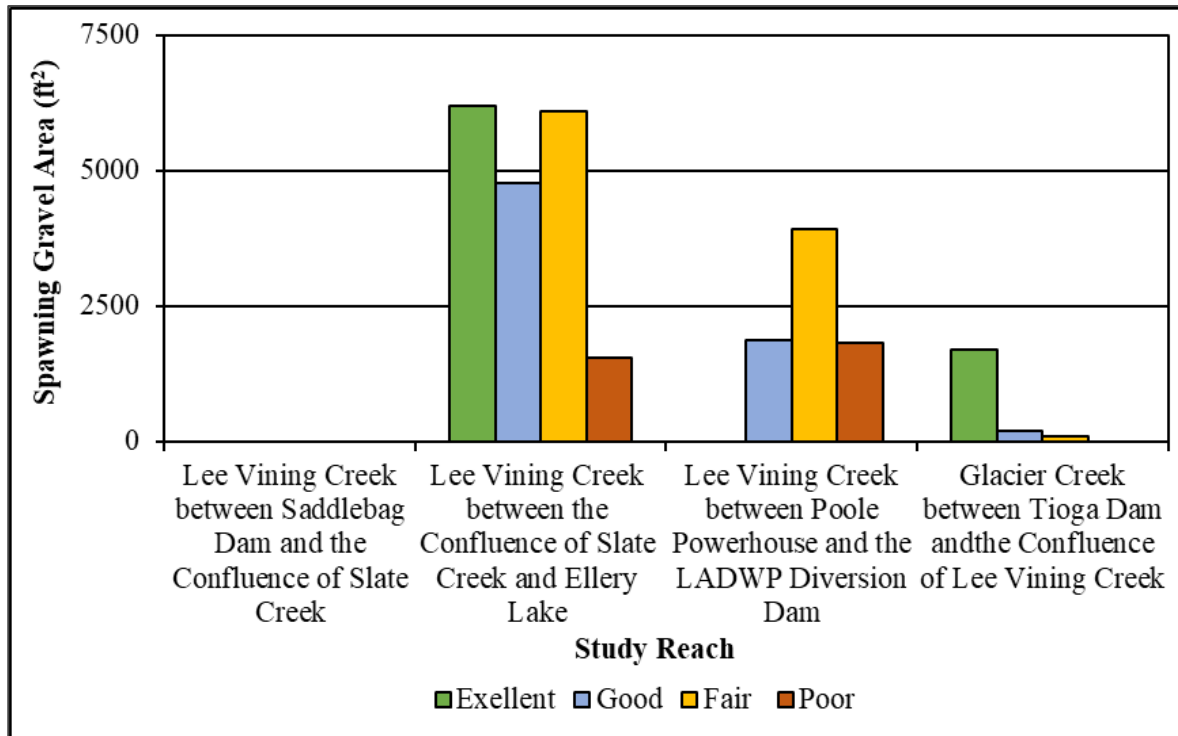
ULVC between Slate and Ellery

– Spawning gravel

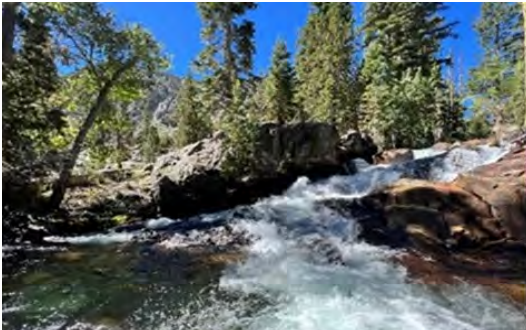
Lower Lee Vining Creek

- Six barriers observed: natural bedrock waterfalls or cascades, culverts under Hwy 120

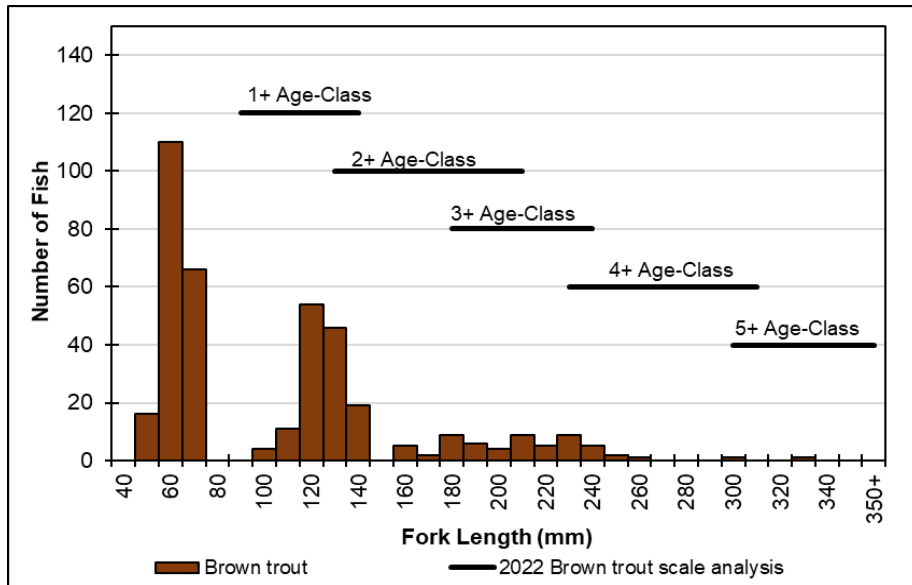
ULVC downstream of Saddlebag Lake: Brown trout

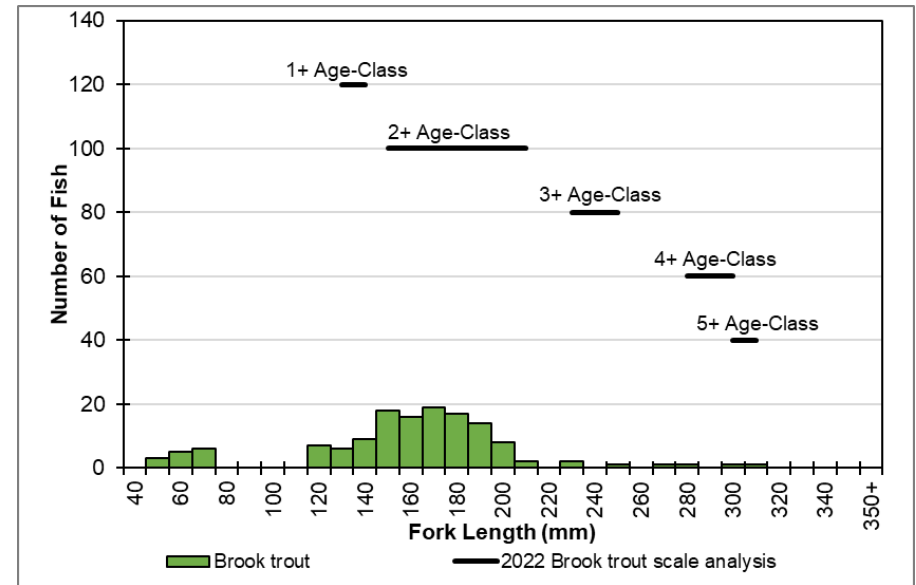
ULVC downstream of Saddlebag Lake: Brook trout

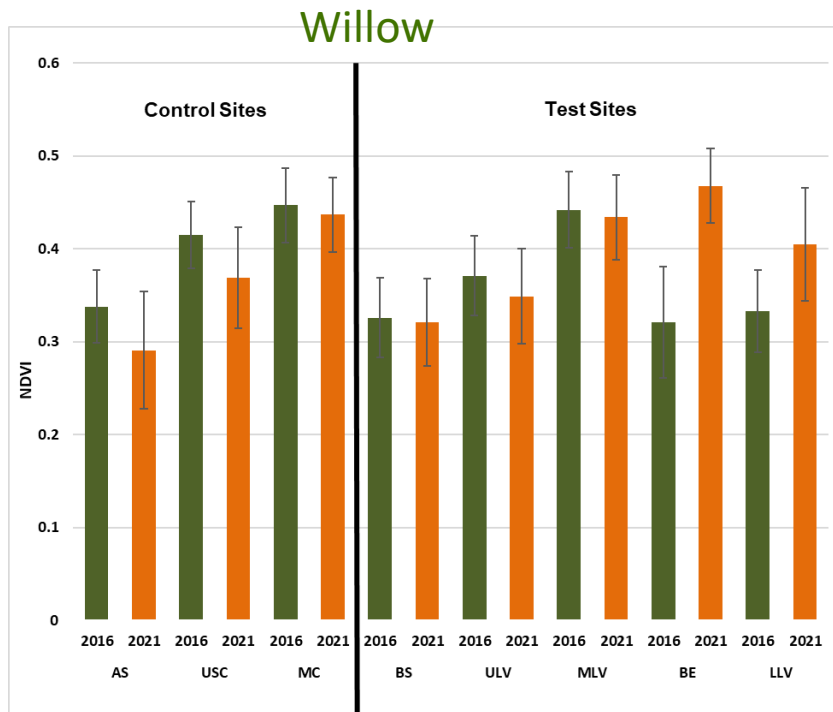
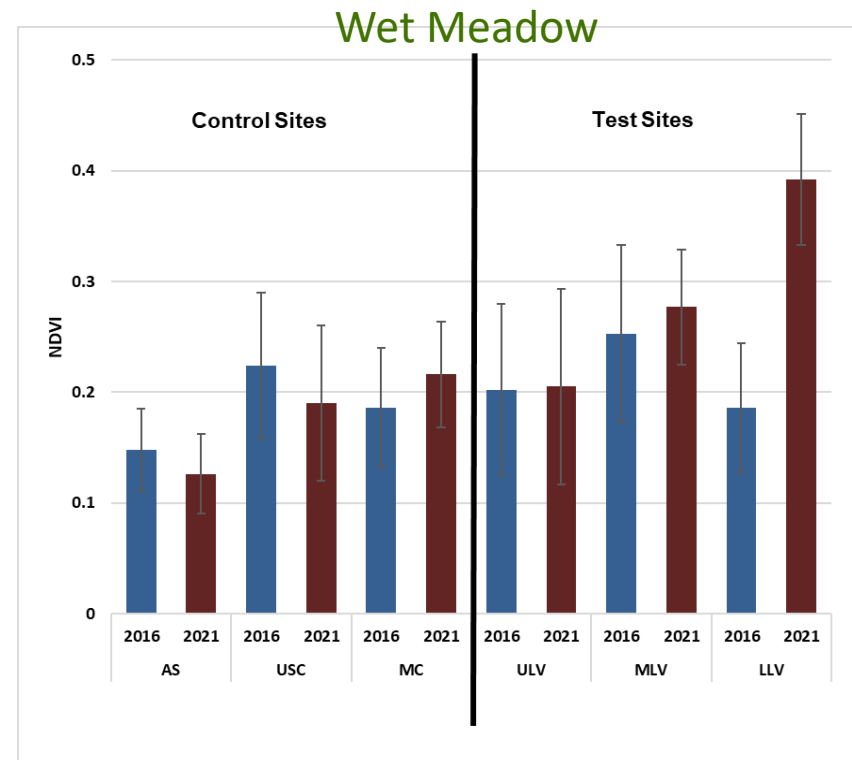
- NDVI analysis – measures "greenness" as a proxy for health
 - Compared "test" sites (below SCE facilities) with "control" sites (not below SCE facilities) using 2016 and 2021 imagery.
 - Looked at willow riparian scrub and wet meadow areas.
