### 3.7 GEOLOGY AND SOILS

Pre-Application Document		Kaweah Project (FERC Project No. 298)
	TABLES

Figure 3.7-1a-d. Representative Photographs of the Spill Drainages Associated with the Kaweah No. 2 Forebay.

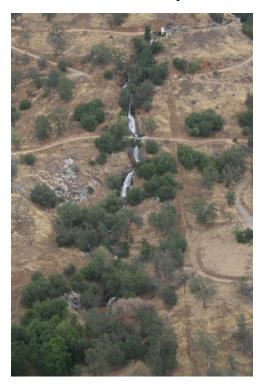
a. View of Kaweah No. 2 main spill drainage on July 1, 2015. Flow is approximately 10 cfs.

The primary spill drainage is located adjacent to the forebay and receives spill flows up to 40 cfs. The drainage is approximately 0.23-mile long and flows into the Kaweah No. 2 Tailrace. Figure 3.7-1a shows the primary drainage on July 1, 2015 with approximately 10 cfs of water. The other two spill drainages are located along the flowline (Map 3.7-5), and receive spills up to 47 cfs. These two smaller drainages converge approximately 220 feet downslope and then continue downslope to the Kaweah River, discharging approximately 0.16 mile upstream of the Kaweah No. 2 Powerhouse. The upper sections of the three drainages are very steep, with slopes exceeding 50%.

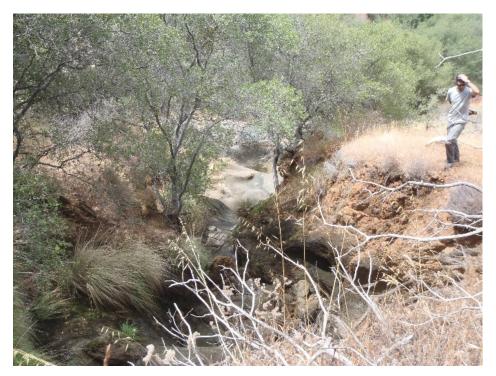
b. Representative photograph of a down cut section in the Kaweah No. 2 main spill drainage.

The three drainages show evidence of incision through the decomposed granite to the underlying granitic bedrock. As shown on Figure 3.7-1b, the upper portion of the main spill drainage has been incised up to 20 feet. Most of the vertical erosion occurred several

decades ago based on the size of the alder trees currently established along the channel margins. The side slopes of the upper sections of the drainages are generally comprised of bedrock or coarse boulders or decomposed granite, with relatively minimal vegetative cover. On-going instability occurs in portions of the drainages where decomposed granite is exposed, and the channel is deeply incised, particularly in the upper portions of the drainages (Figure 3.7-1c). The other bedrock or large boulder sections are stable (e.g., Figure 3.7-1d). The lower portions of the drainages are lower gradient and well vegetated, which reduces the erosion potential.

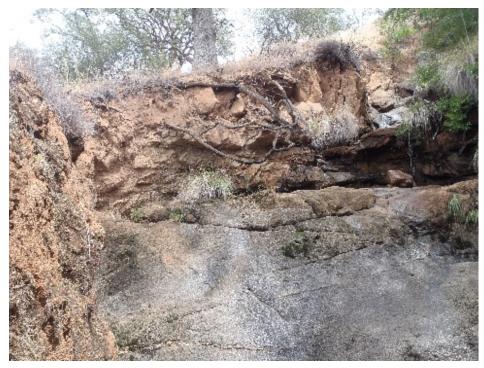
c. Recent erosion on the side slope of the Kaweah No. 2 main spill drainage, near the top of the drainage.

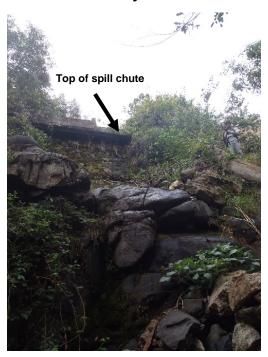
Figure 3.7-2a-e. Representative Photographs of the Spill Drainage Associated with the Kaweah No. 3 Forebay.

a. Representative photograph of the upper portion of the Kaweah No. 3 spill drainage, showing the end of the spill chute.

At Kaweah No. 3 Forebay, up to 97 cfs of flow can spill into an approximate 75-foot long concrete-lined spillway chute that begins at the upstream end of the forebay. The chute discharges into an adjacent drainage that flows approximately 0.3 mile downslope into the Kaweah River (Map 3.7-6). Spills occur periodically and generally last for less than a day. Photographs of the upper portion of the drainage and the top of the spill chute are shown in Figure 3.7-2a. As shown in the figures, the drainage is very narrow and steep (approximately 38% gradient), and is primarily comprised of large boulders and is well vegetated (Figures 3.7-2 b-d). The large substrate that acts as rip-rap and well-vegetated side slopes limit the potential for down cutting and erosion of the side slopes. At the confluence with the Kaweah River, the drainage is vegetated, with no large sediment deposits at the margins of the channel (Figure 3.7-2e).

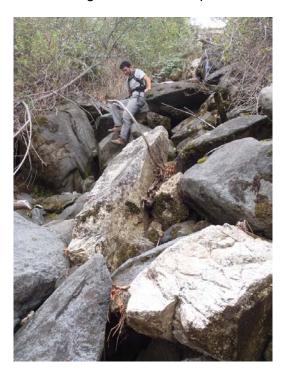
b. Representative section Kaweah No. 3 spill drainage, illustrating the steep, bedrock/boulder nature of this drainage.

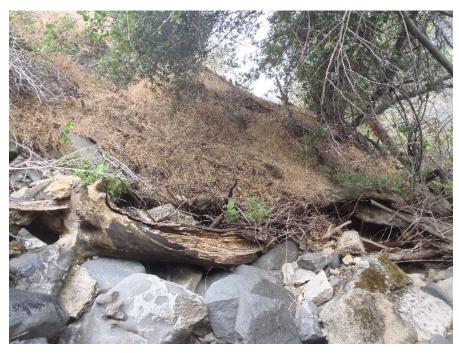
c. Representative section of the Kaweah No. 3 spill drainage showing boulders along the side slopes of the drainage.

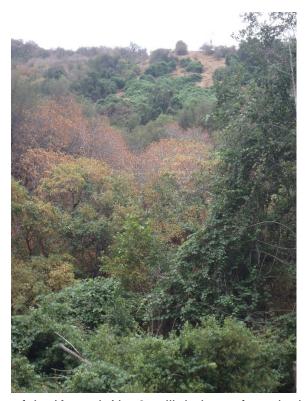
d. View of the Kaweah No. 3 spill drainage from the bottom.

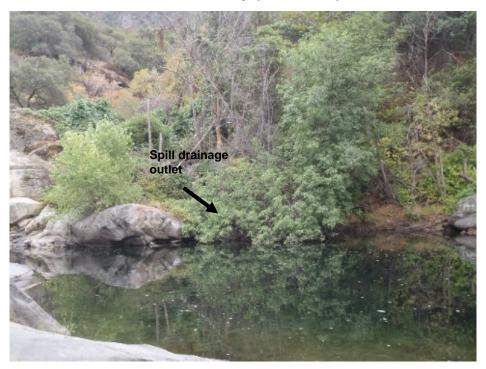
e. Outlet of the Kaweah No. 3 spill drainage at the Kaweah River
